# Access Compliance Report Public Rights-of-Way (Curb Ramps)

| Main Street: FOSTER_RD | | Cross Street: SHAKESPEARE_DR | | Location: | NW |
| ADA ID: RPAT211202095851 | Ramp Type:Type 1 - Perpendicular Diagonal Initial Pass/Fail: Pass | | Overall Compliance: No | Severity Score: | 0 |

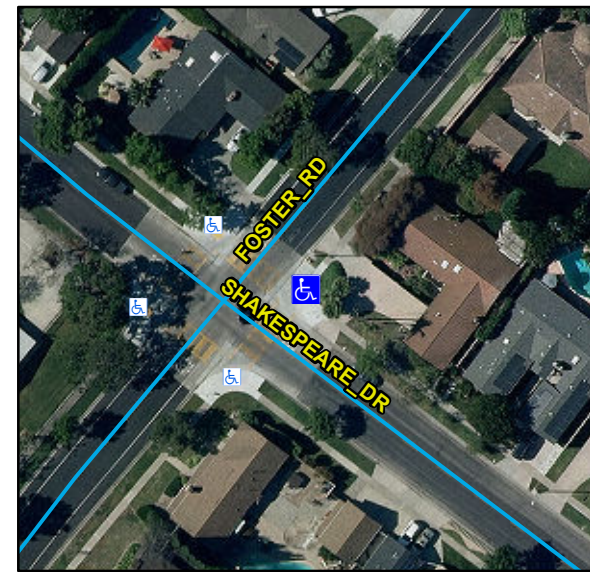
| Compliance | Description | Data | Compliance | Description | Data |
|---|---|---|---|---|---|
| No | Landing Run Slope (%) | 2.2 | N/A | Flare Traversable RT | No |
| | Landing Movement Type | Bushes | Yes | DWS Length (in) | 36 |

Possible Solutions:

**Remove & Replace Landing.**

**R304.2.1, R304.2.2-Perp, R304.3.2-Para, STD 1115**
