# Access Compliance Report Public Rights-of-Way (Curb Ramps)

Main Street: DONOVAN\_RD Cross Street: SILVERWOOD\_DR Location: E

ADA ID: RPAT211202121739 Ramp Type: Type 1 - Perpendicular Diagonal Initial Pass/Fail: Pass Overall Compliance: No Severity Score: 14

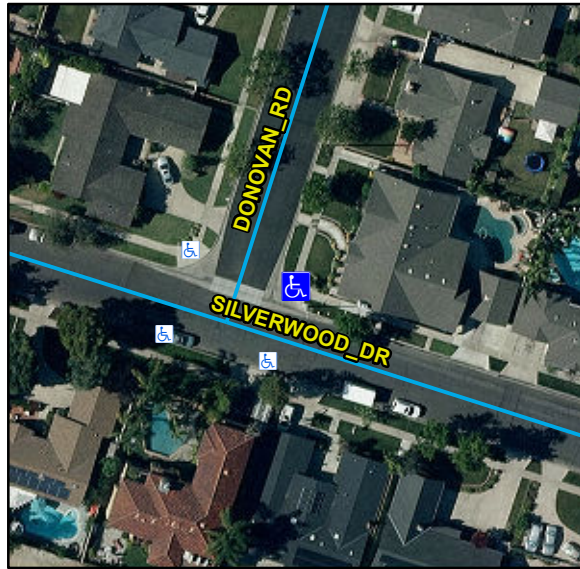
## Field Measurements/Component Compliance

| Compliance | Description | Data | Compliance | Description | Data |
|---|---|---|---|---|---|
| No | Landing Run Slope (%) | 2.7 | N/A | Flare Traversable RT | No |
| Yes | Landing Cross Slope (%) | 1.5 | No | DWS Provided | No |
| N/A | Landing Movement Obstructed? | Yes | N/A | DWS Contrast | N/A |
| | Landing Movement Type | Bushes | N/A | DWS Length (in) | N/A |

Remove & Replace Curb Ramp With Two New Directional Ramps or Equivalent.
