# Access Compliance Report Public Rights-of-Way (Curb Ramps)

Main Street: **PIEDMONT\_AVE** Cross Street: **WEMBLEY\_RD** Location: **S**

ADA ID: **RPAT211206112752** Ramp Type: **Type 1 - Perpendicular Diagonal Initial Pass/Fail: Pass** Overall Compliance: **No** Severity Score: **0**

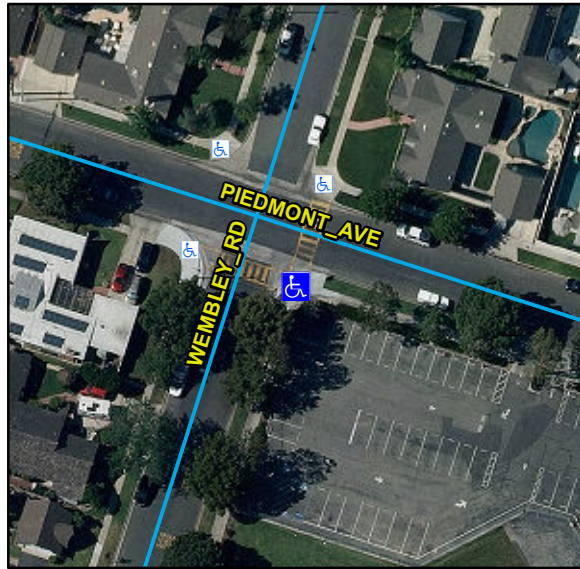
Possible Solutions:

| Compliance | Description | Data | Compliance | Description | Data |
|---|---|---|---|---|---|
| <b>N/A</b> | Landing Movement Obstructed? | <b>Yes</b> | <b>Yes</b> | DWS Contrast | <b>Yes</b> |
| | Landing Movement Type | <b>fence</b> | <b>Yes</b> | DWS Length (in) | <b>36</b> |

**Remove & Replace Landing.**

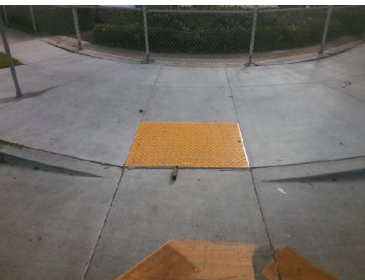
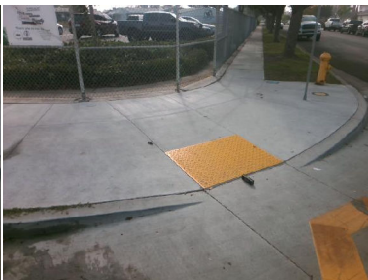
| Compliance | Description | Data | Compliance | Description | Data |
|---|---|---|---|---|---|
| <b>Yes</b> | Overall Surface Condition: <b>Acceptable</b> | | <b>Yes</b> | Perp Joint Present | <b>Yes</b> |
| | Cross Gutter Present? | <b>Yes</b> | | Spandrel Present? | <b>Yes</b> |
| | Replace Cross Gutter? | <b>No</b> | | Replace Spandrel? | <b>No</b> |
