# Access Compliance Report Public Rights-of-Way (Curb Ramps)

Main Street: MARTHA\_ANN\_DR Cross Street: CHANNING\_WAY Location: E

ADA ID: RPAT211206121659 Ramp Type: Type 1 - Perpendicular Diagonal Initial Pass/Fail: Pass Overall Compliance: No Severity Score: 2

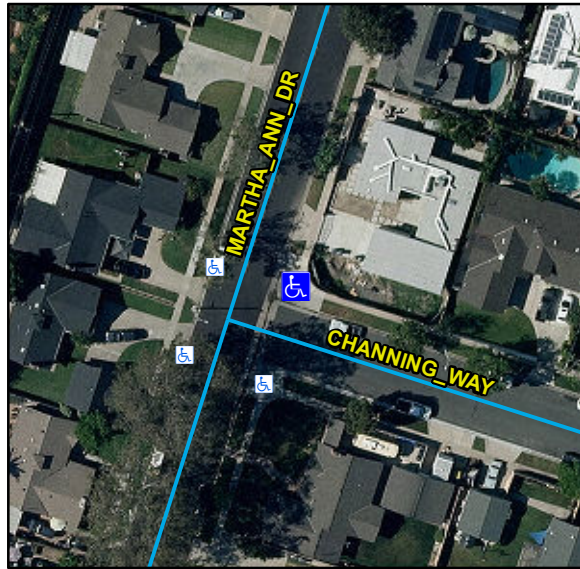
| Compliance | Description | Data | Compliance | Description | Data |
|---|---|---|---|---|---|
| No | Landing Run Slope (%) | 3 | N/A | Flare Traversable RT | No |
| Yes | Gutter Ponding | No | No | Curb Slope | 9.4 |

Remove & Replace Curb Ramp With Two New Directional Ramps or Equivalent.
