# Access Compliance Report Public Rights-of-Way (Curb Ramps)

| Main Street: ST_ALBANS_DR | | Cross Street: MARTHA_ANN_DR | | Location: | S |
| ADA ID: RPAT211206124718 | Ramp Type:Type 1 - Perpendicular Diagonal Initial Pass/Fail: Pass | | Overall Compliance: No | Severity Score: | 4 |

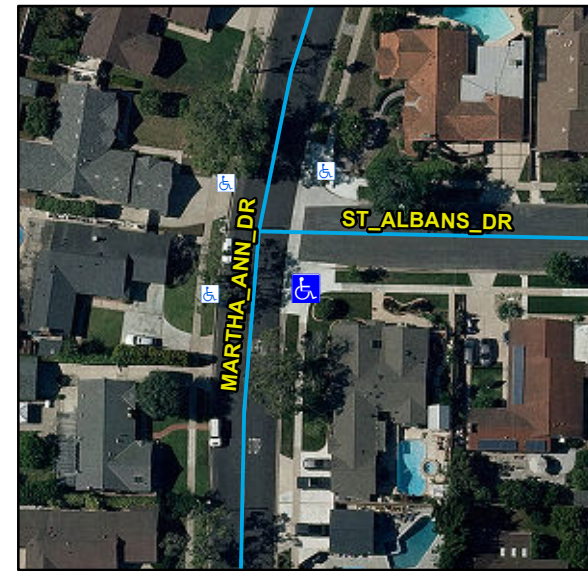
| Compliance | Description | Data | Compliance | Description | Data |
|---|---|---|---|---|---|
| No | Landing Width (in) | 47 | N/A | Flare Slope RT (%) | 5.4 |
| No | Landing Run Slope (%) | 2.3 | N/A | Flare Traversable RT | No |

Possible Solutions:

Remove & Replace Landing.

R304.2.1, R304.2.2-Perp, R304.3.2-Para, STD 1115
