Main Street: N/A Cross Street: S\_DAISSY\_ST Location: W

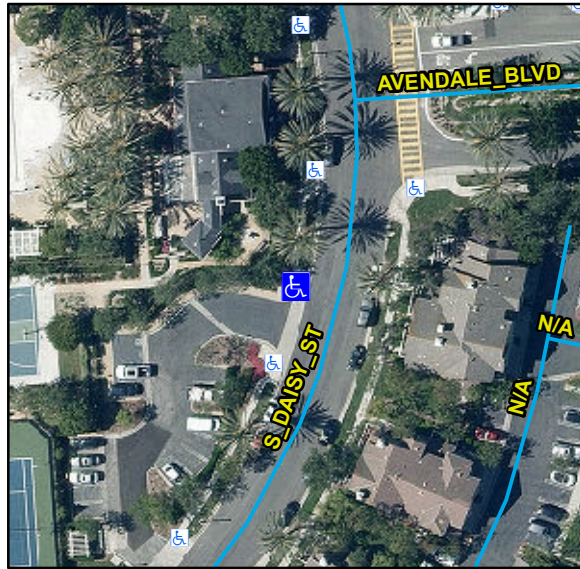
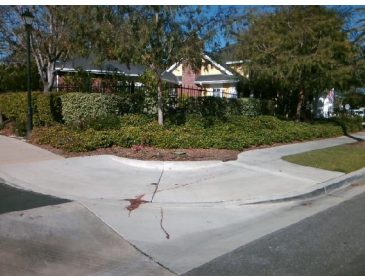
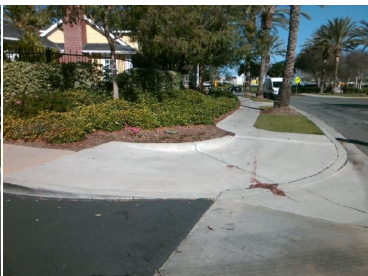
ADA ID: RPAT220125103730 Ramp Type: Type 4 - Parallel Initial Pass/Fail: Pass Overall Compliance: No Severity Score: 20

| Compliance | Description | Data | Compliance | Description | Data |
|---|---|---|---|---|---|
| N/A | Landing Present | No | No | DWS Provided | No |
| No | Landing Width (in) | N/A | N/A | DWS Length (in) | N/A |
| No | Landing Run Slope (%) | N/A | N/A | DWS Full Width | N/A |
| No | Landing Cross Slope (%) | N/A | | DWS Offset Type | N/A |
| No | Gutter Cross Slope (%) | 4.7 | No | Perpendicular Joint Present | No |

Remove & Replace Entire Ramp. Remove & Replace Gutter.
