# Access Compliance Report Public Rights-of-Way (Curb Ramps)

Main Street: ORANGE\_OLIVE\_RD Cross Street: LINCOLN\_AVE Location: SW

ADA ID: RPAT220127101729 Ramp Type: Type 7 - Directional 2 Initial Pass/Fail: Pass Overall Compliance: No Severity Score: 24

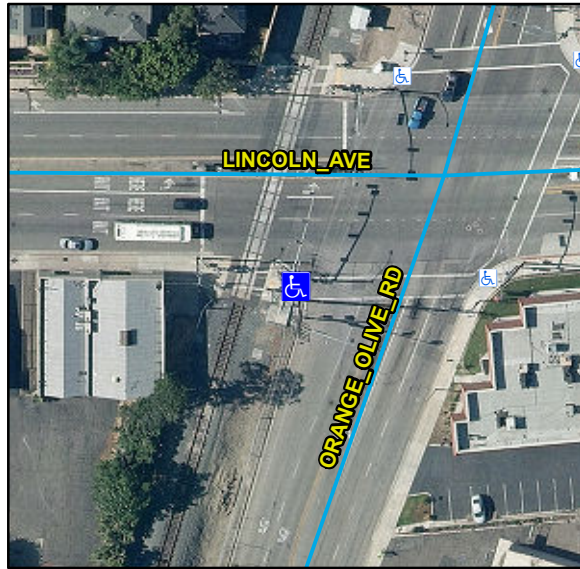
| Compliance | Description | Data | Compliance | Description | Data |
|---|---|---|---|---|---|
| No | Ramp Cross Slope (%) | 5.7 | N/A | Flare Traversable LT | N/A |
| No | Landing Width (in) | 46 | Yes | DWS Full Width | Yes |
| No | Landing Run Slope (%) | 4.1 | | DWS Offset Type | Single |
| No | Landing Cross Slope (%) | 2.7 | Yes | DWS Left Offset (in) | 0 |
| No | Gutter Run Slope (%) | 7.3 | | Road Cross Slope (%) | N/A |
| No | Gutter Cross Slope (%) | 6.6 | | Parallel Ramp Side | Left |

Remove & Replace Entire Ramp. Remove & Replace Gutter.
