# Access Compliance Report Public Rights-of-Way (Curb Ramps)

| Main Street: BARCLAY_DR | | Cross Street: KATELLA_AVE | | Location: | SE |
| ADA ID: RPAT220202104822 | Ramp Type:Type 1 - Perpendicular | Initial Pass/Fail: Pass | Overall Compliance: No | Severity Score: | 6 |

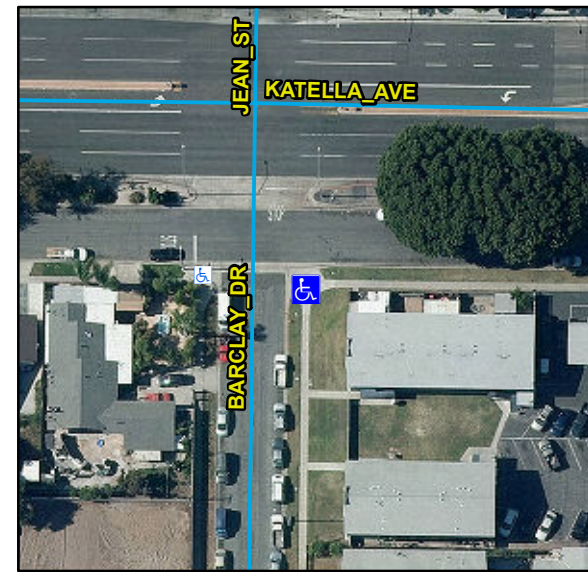
| Compliance | Description | Data | Compliance | Description | Data |
|---|---|---|---|---|---|
| No | Landing Run Slope (%) | 2.4 | N/A | Flare Traversable RT | Yes |
| Yes | Gutter Ponding | No | No | Curb Slope | 11.1 |

Possible Solutions:

Remove & Replace Entire Ramp.
