# Access Compliance Report Public Rights-of-Way (Curb Ramps)

Main Street: HAZARD\_AVE Cross Street: NEWLAND\_ST Location: NW

ADA ID: RPAT220221144730 Ramp Type: Type 4 - Parallel Initial Pass/Fail: Pass Overall Compliance: No Severity Score: 20

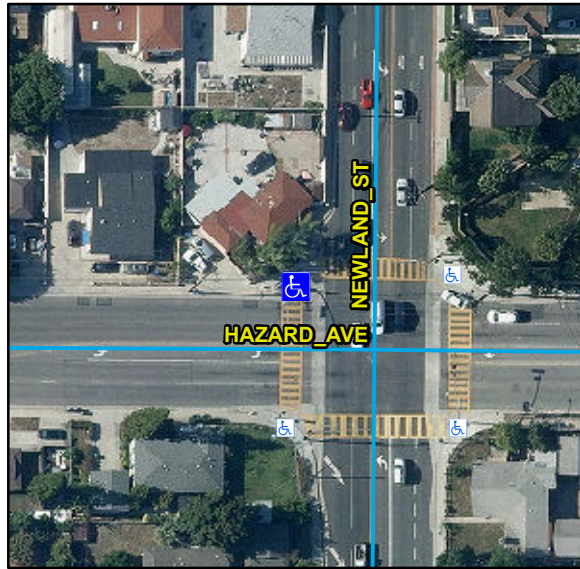
| Compliance | Description | Data | Compliance | Description | Data |
|---|---|---|---|---|---|
| Yes | Gutter Ponding | No | No | Curb Slope | 9.4 |
| No | Gutter Run Slope (%) | 5.6 | | Road Cross Slope (%) | 3.1 |
| No | Overall Surface Condition | Poor | | | |

Remove & Replace Curb Ramp With Two New Directional Ramps or Equivalent. Remove & Replace Gutter. Utility Present.

R304.2.2, R302.7, R304.5.4, STD 1115
