# Access Compliance Report Public Rights-of-Way (Curb Ramps)

Main Street: HAZARD\_AVE Cross Street: NEWLAND\_ST Location: SE

ADA ID: RPAT220221150954 Ramp Type: Type 4 - Parallel Initial Pass/Fail: Fail Overall Compliance: No Severity Score: 16

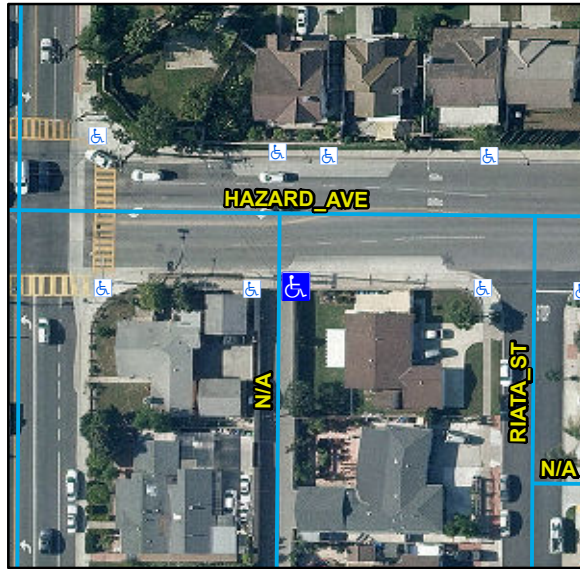
| Compliance | Description | Data | Compliance | Description | Data |
|---|---|---|---|---|---|
| No | Ramp Run Slope LT (%) | 9 | Yes | Ramp Run Slope RT (%) | 6.7 |
| No | Ramp Cross Slope LT (%) | 4.7 | No | Ramp Cross Slope RT (%) | 3.3 |

Remove & Replace Entire Ramp.

R304.3.2, R304.5.3, STD 1115

Total Cost: \$ 2000
