# Access Compliance Report Public Rights-of-Way (Curb Ramps)

Main Street: BOLSA\_AVE\_FRONTAGE\_ROAD Cross Street: N/A Location: N

ADA ID: RPAT220221153008 Ramp Type: Type 4 - Parallel Initial Pass/Fail: Fail Overall Compliance: No Severity Score: 34

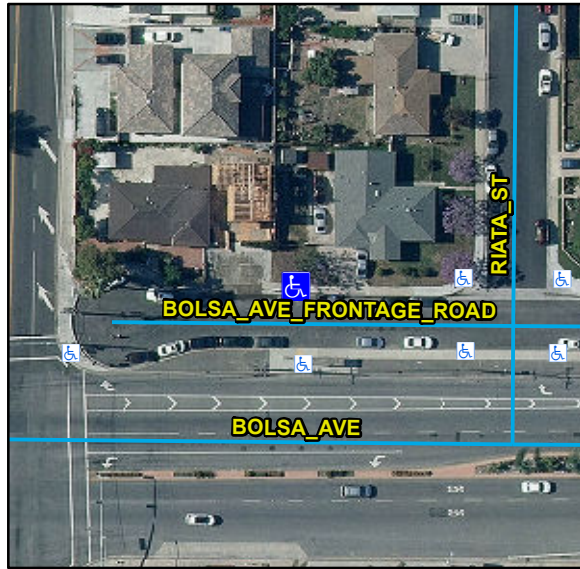
| Compliance | Description | Data | Compliance | Description | Data |
|---|---|---|---|---|---|
| No | Ramp Width LT (in) | 47 | No | Ramp Width RT (in) | 47 |
| Yes | Ramp Run Slope LT (%) | 6.8 | No | Ramp Run Slope RT (%) | 8.9 |
| N/A | Gutter Ponding | Yes | N/A | Curb Slope | 1.2 |
| No | Overall Surface Condition | Poor | | | |

Remove & Replace Entire Ramp.

R304.5.1, R304.3.2, R302.7, STD 1115

Total Cost: \$ 2000
