# Access Compliance Report Public Rights-of-Way (Curb Ramps)

| Main Street: ARROYO_LINDO_DR | | Cross Street: ARROYO_AVE | | Location: | NE |
| ADA ID: RPAT220225160612 | Ramp Type: Type 4 - Parallel | Initial Pass/Fail: Pass | Overall Compliance: Yes | Severity Score: | 0 |

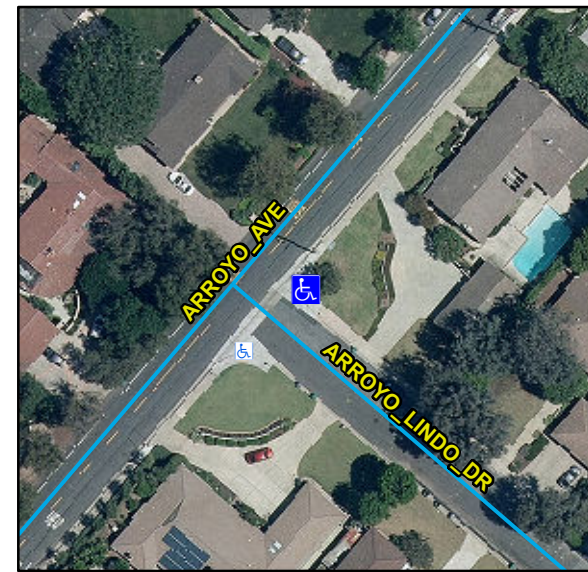
Surveyor Notes:

N/A

Possible Solutions:

N/A

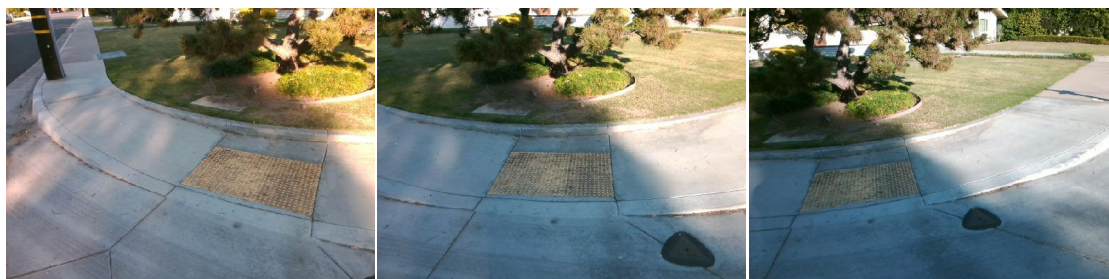
| Compliance | Description | Data | Compliance | Description | Data |
|---|---|---|---|---|---|
| N/A | Ramp Length LT (in) | 118 | N/A | Ramp Length RT (in) | 118 |
| Yes | Ramp Width LT (in) | 60 | Yes | Ramp Width RT (in) | 60 |
| Yes | Ramp Run Slope LT (%) | 5.6 | Yes | Ramp Run Slope RT (%) | 2.7 |
| Yes | Ramp Cross Slope LT (%) | 1.4 | Yes | Ramp Cross Slope RT (%) | 0.9 |
| Yes | Landing Width (in) | 48 | Yes | DWS Length (in) | 36 |
| Yes | Landing Run Slope (%) | 1.4 | Yes | DWS Full Width | Yes |
| Yes | Landing Cross Slope (%) | 0.2 | | DWS Offset Type | Single |
