# Access Compliance Report Public Rights-of-Way (Curb Ramps)

Main Street: **HAMER\_LN** Cross Street: **ROCKAWAY\_DR** Location: **SW**

ADA ID: **RPRK210917122522** Ramp Type: **Type 1 - Perpendicular Diagonal** Initial Pass/Fail: **Pass** Overall Compliance: **No** Severity Score: **4**

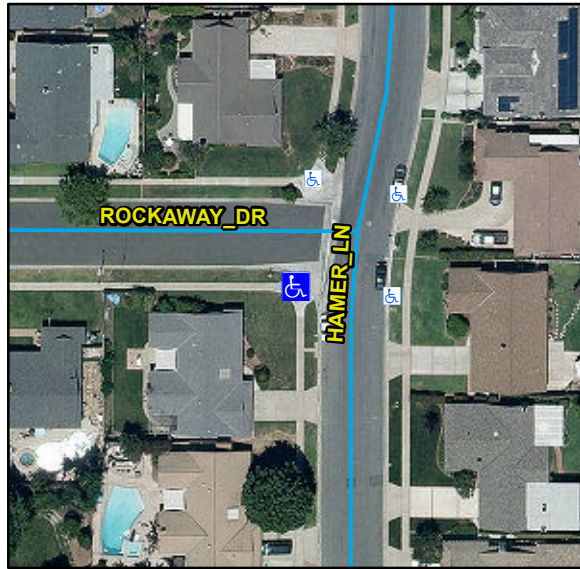
| Compliance | Description | Data | Compliance | Description | Data |
|---|---|---|---|---|---|
| Yes | Gutter Ponding | No | No | Curb Slope | 9.5 |

**Remove & Replace Curb Ramp With Two New Directional Ramps or Equivalent.**

**R304.2.2, R304.2.1, STD 1115**
