# Access Compliance Report Public Rights-of-Way (Curb Ramps)

Main Street: CEDARLAWN\_DR Cross Street: ROCKAWAY\_DR Location: NE

ADA ID: RPRK210917132407 Ramp Type: Type 1 - Perpendicular Diagonal Initial Pass/Fail: Pass Overall Compliance: No Severity Score: 6

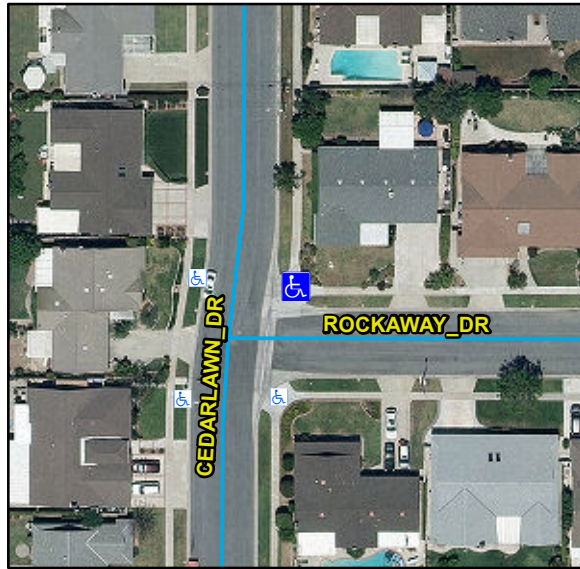
R304.2.2, R304.2.1, STD 1115

| Compliance | Description | Data | Compliance | Description | Data |
|---|---|---|---|---|---|
| Yes | Gutter Ponding | No | No | Curb Slope | 13.1 |

Remove & Replace Curb Ramp With Two New Directional Ramps or Equivalent.
