# Access Compliance Report

## Public Rights-of-Way

### (Curb Ramps)

Main Street: CEDARLAWN\_DR Cross Street: SKYMEADOW\_DR Location: NE

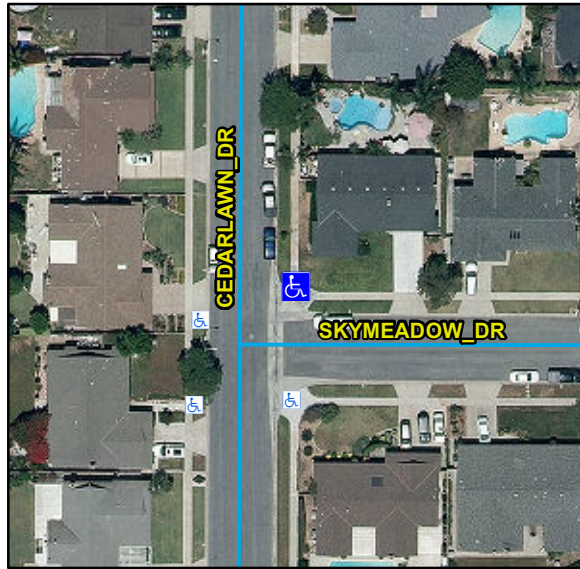
ADA ID: RPRK210917133850 Ramp Type: Type 1 - Perpendicular Diagonal Initial Pass/Fail: Pass Overall Compliance: No Severity Score: 6

Remove & Replace Landing.

R304.2.1, STD 1115
