# Access Compliance Report Public Rights-of-Way (Curb Ramps)

Main Street: SHADBURN\_AVE Cross Street: MCCORMACK\_LN Location: NW

ADA ID: RPRK210917160931 Ramp Type: Type 1 - Perpendicular Diagonal Initial Pass/Fail: Fail Overall Compliance: No Severity Score: 2

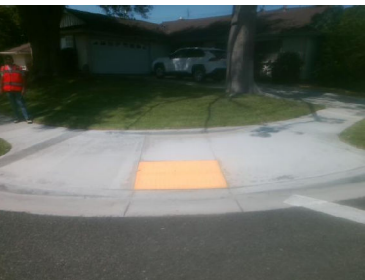
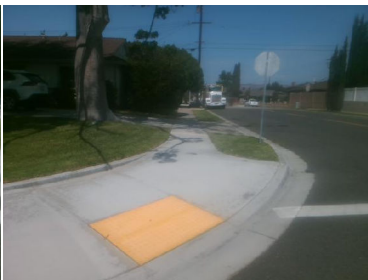
| Compliance | Description | Data | Compliance | Description | Data |
|---|---|---|---|---|---|
| No | Ramp Cross Slope (%) | 3.9 | N/A | Flare Traversable LT | N/A |

**Remove & Replace Curb Ramp With Two New Directional Ramps or Equivalent.**
