# Access Compliance Report Public Rights-of-Way (Curb Ramps)

Main Street: N/A Cross Street: KATELLA\_AVE Location: SW

ADA ID: RPRK210921125755 Ramp Type: Type 1 - Perpendicular Diagonal Initial Pass/Fail: Pass Overall Compliance: No Severity Score: 0

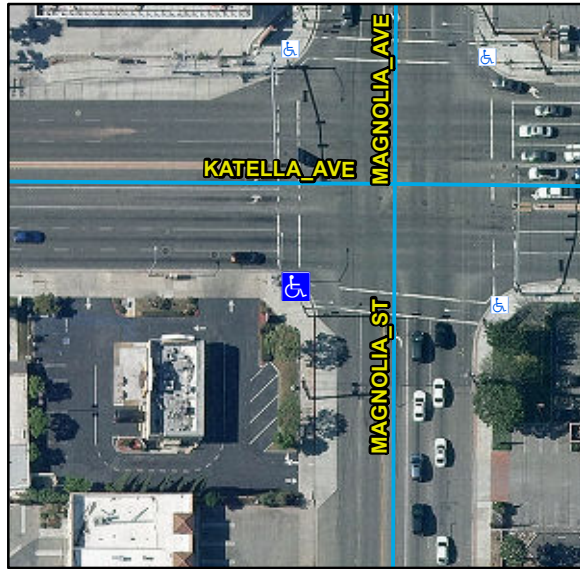
| Compliance | Description | Data | Compliance | Description | Data |
|---|---|---|---|---|---|
| No | Landing Run Slope (%) | 2.1 | N/A | Flare Traversable RT | No |
| No | Gutter Ponding | Yes | Yes | Curb Slope | 3 |
| No | Gutter Cross Slope (%) | 2.3 | | | |

Remove & Replace Landing. Remove & Replace Gutter.
