# Access Compliance Report Public Rights-of-Way (Curb Ramps)

Main Street: KATELLA\_AVE Cross Street: N/A Location: SE

ADA ID: RPRK210921130958 Ramp Type: Type 1 - Perpendicular Diagonal Initial Pass/Fail: Pass Overall Compliance: No Severity Score: 6

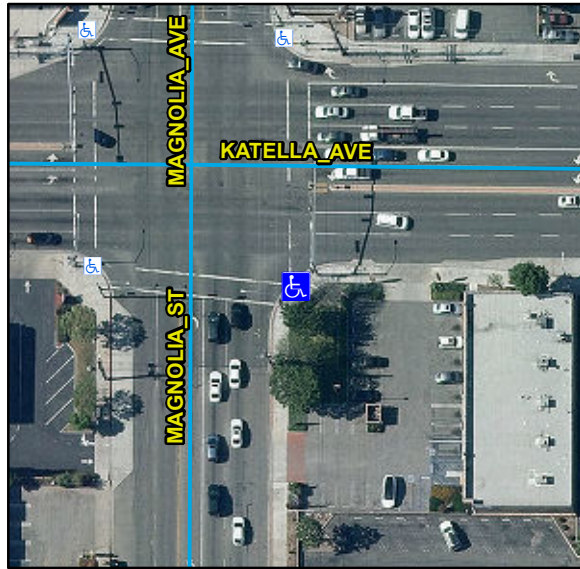
| Compliance | Description | Data | Compliance | Description | Data |
|---|---|---|---|---|---|
| No | Gutter Ponding | Yes | No | Curb Slope | 9.3 |
| No | Gutter Cross Slope (%) | 6.4 | | | |

Remove & Replace Curb Ramp With Two New Directional Ramps or Equivalent. Remove & Replace Gutter.

R304.2.2, R304.2.1, R302.7, R304.5.3, STD 1115
