# Access Compliance Report Public Rights-of-Way (Curb Ramps)

**Main Street:** MAGNOLIA\_AVE      **Cross Street:** MAGNOLIA\_AVE      **Location:** W

**ADA ID:** RPRK210921155934      **Ramp Type:** Type 4 - Parallel      **Initial Pass/Fail:** Fail      **Overall Compliance:** No      **Severity Score:** 2

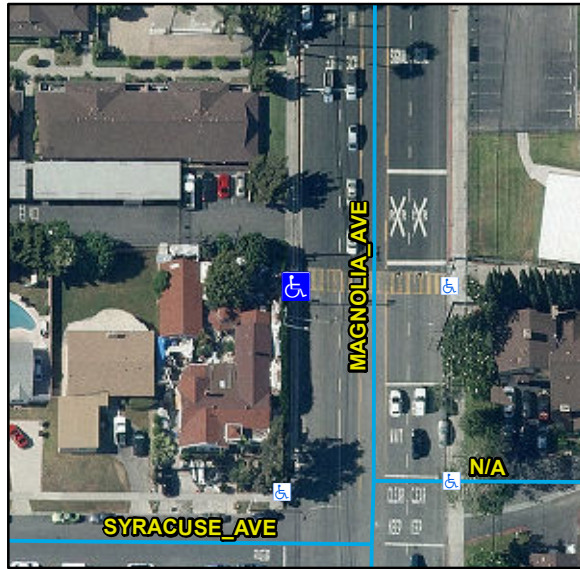
Compliance	Description	Data	Compliance	Description	Data
N/A	Ramp Length LT (in)	87	N/A	Ramp Length RT (in)	88
Yes	Ramp Width LT (in)	88	Yes	Ramp Width RT (in)	86
Yes	Ramp Run Slope LT (%)	5.9	Yes	Ramp Run Slope RT (%)	5.9
Yes	Ramp Cross Slope LT (%)	0.9	No	Ramp Cross Slope RT (%)	2.8
N/A	Landing Present	N/A	N/A	DWS Provided	N/A
N/A	Landing Length (in)	N/A	N/A	DWS Contrast	N/A
N/A	Landing Width (in)	N/A	N/A	DWS Length (in)	N/A
N/A	Landing Run Slope (%)	N/A	N/A	DWS Full Width	N/A
N/A	Landing Cross Slope (%)	N/A		DWS Offset Type	N/A
N/A	Landing Movement Obstructed?	N/A	N/A	DWS Offset Left (in)	N/A
	Landing Movement Type	N/A	N/A	DWS Offset Right (in)	N/A
N/A	Landing Shared	N/A			
N/A	Clear Space	N/A			
N/A	Clear Space To Crosswalk (in)	N/A			
N/A	Marked Crosswalk 1	Yes	N/A	Marked Crosswalk 2	N/A
	Crossing 1 Direction	E		Crossing 2 Direction	N/A
N/A	Marked Crosswalk 1 Width (in)	140		Marked Crosswalk 2 Width (in)	N/A

N/A	Ramp Inside Crosswalk 1	Yes	N/A	Ramp Inside Crosswalk 2	N/A
	Crossing 1 Slope (%)	6.8		Crossing 2 Slope (%)	N/A
	Crossing 1 Cross Slope (%)	0.2		Crossing 2 Cross Slope (%)	N/A
N/A	Gutter Ponding	N/A	N/A	Curb Slope	5.8
Yes	Gutter Lip Height (in)	0		Road Run Slope (%)	N/A
N/A	Gutter Run Slope (%)	N/A		Road Cross Slope (%)	N/A
N/A	Gutter Cross Slope (%)	N/A	Yes	Perpendicular Joint Present	Yes
Yes	Overall Surface Condition	Acceptable		Spandrel Present?	No
	Cross Gutter Present?	No		Replace Spandrel?	N/A
	Replace Cross Gutter?	N/A

**Possible Solutions:**  
**Remove & Replace Entire Ramp.**

**OC Std/PROW:**  
 R304.5.3, STD 1115

**Total Cost:**      \$      2000
