# Access Compliance Report Public Rights-of-Way (Curb Ramps)

Main Street: BEACH\_BLVD Cross Street: BOLSA\_AVE Location: NE

ADA ID: RPRK210929152048 Ramp Type: Type 1 - Perpendicular Diagonal Initial Pass/Fail: Pass Overall Compliance: No Severity Score: 6

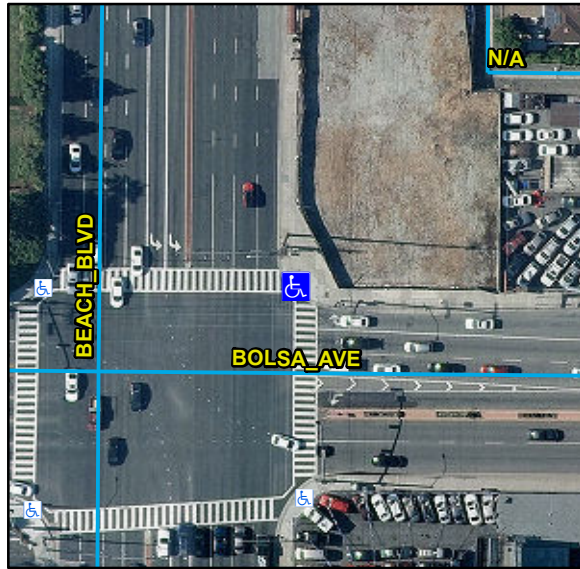
| Compliance | Description | Data | Compliance | Description | Data |
|---|---|---|---|---|---|
| No | Landing Run Slope (%) | 2.3 | N/A | Flare Traversable RT | No |
| No | Gutter Ponding | Yes | No | Curb Slope | 9.4 |

Remove & Replace Curb Ramp With Two New Directional Ramps or Equivalent.
