# Access Compliance Report Public Rights-of-Way (Curb Ramps)

Main Street: BEACH\_BLVD Cross Street: BOLSA\_AVE Location: SW

ADA ID: RPRK210929153702 Ramp Type: Type 1 - Perpendicular Diagonal Initial Pass/Fail: Pass Overall Compliance: No Severity Score: 8

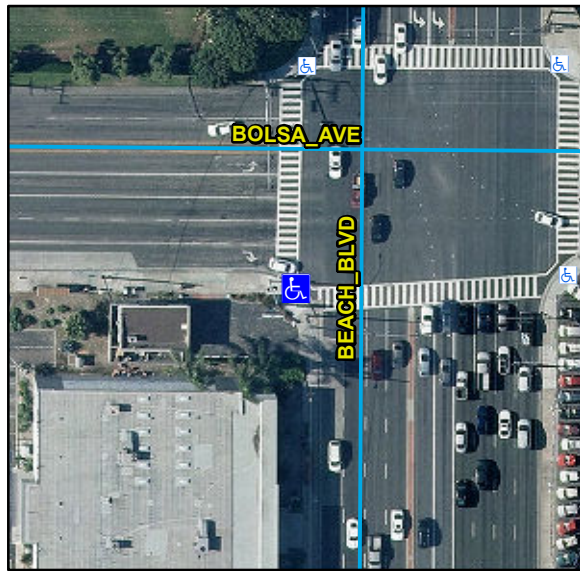
Remove & Replace Landing. Gutter Ponding Observed.

| Compliance | Description | Data | Compliance | Description | Data |
|---|---|---|---|---|---|
| No | Landing Run Slope (%) | 3.4 | N/A | Flare Traversable RT | No |
| No | Gutter Ponding | Yes | Yes | Curb Slope | 1.1 |

### Possible Solutions:
