# Access Compliance Report Public Rights-of-Way (Curb Ramps)

Main Street: JACKSON\_ST Cross Street: BOLSA\_AVE Location: SW

ADA ID: RPRK211004172309 Ramp Type: Type 1 - Perpendicular Diagonal Initial Pass/Fail: Fail Overall Compliance: No Severity Score: 19

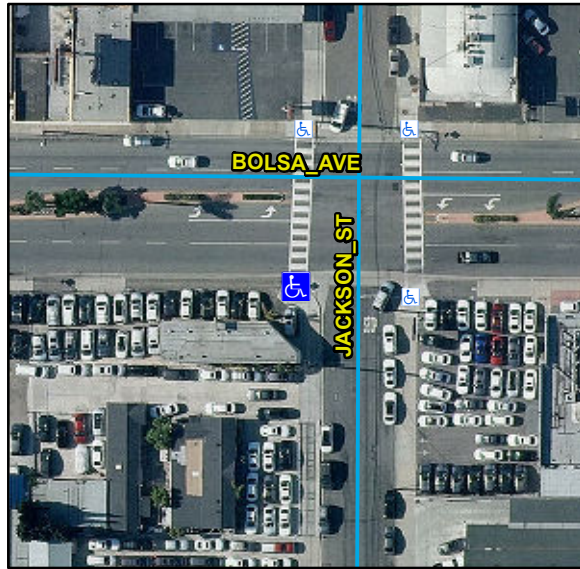
| Compliance | Description | Data | Compliance | Description | Data |
|---|---|---|---|---|---|
| No | Ramp Width (in) | 36 | | | N/A |
| No | Ramp Run Slope (%) | 9.8 | N/A | Flare Slope LT (%) | N/A |

Remove & Replace Curb Ramp With Two New Directional Ramps or Equivalent.
