# Access Compliance Report Public Rights-of-Way (Curb Ramps)

Main Street: HARPER\_ST Cross Street: BOLSA\_AVE Location: NE

ADA ID: RPRK211004181500 Ramp Type: Type 1 - Perpendicular Diagonal Initial Pass/Fail: Fail Overall Compliance: No Severity Score: 4

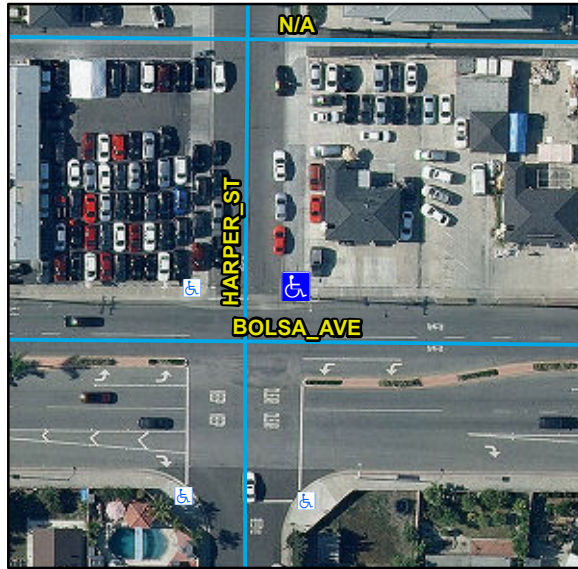
| Compliance | Description | Data | Compliance | Description | Data |
|---|---|---|---|---|---|
| No | Ramp Width (in) | 36 | | | N/A |

Remove & Replace Curb Ramp With Two New Directional Ramps or Equivalent.

R304.5.1, STD 1115
