# Access Compliance Report Public Rights-of-Way (Curb Ramps)

Main Street: COLONIAL\_DR Cross Street: HAZARD\_AVE Location: SW

ADA ID: RPRK211005113927 Ramp Type: Type 1 - Perpendicular Diagonal Initial Pass/Fail: Fail Overall Compliance: No Severity Score: 15

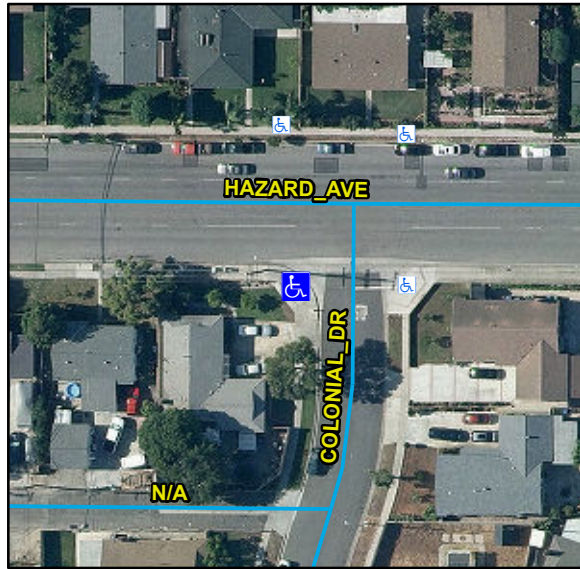
| Compliance | Description | Data | Compliance | Description | Data |
|---|---|---|---|---|---|
| No | Ramp Run Slope (%) | 8.9 | N/A | Flare Slope LT (%) | N/A |

Remove & Replace Curb Ramp With Two New Directional Ramps or Equivalent.

R304.2.2, STD 1115
