# Access Compliance Report Public Rights-of-Way (Curb Ramps)

| Main Street: BOLSA_AVE | | Cross Street: PURDY_ST | | Location: | E |
| ADA ID: RPRK211005131642 | Ramp Type: Type 4 - Parallel | Initial Pass/Fail: Fail | Overall Compliance: No | Severity Score: | 5 |

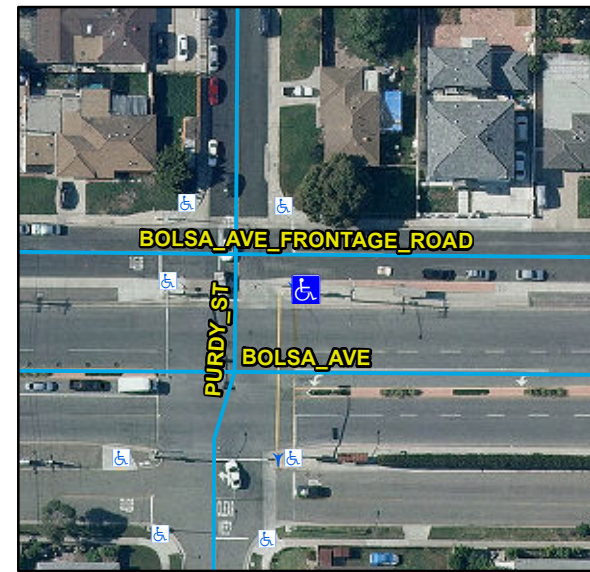
| Compliance | Description | Data | Compliance | Description | Data |
|---|---|---|---|---|---|
| No | Ramp Width LT (in) | 47 | N/A | Ramp Width RT (in) | N/A |
| No | Ramp Cross Slope LT (%) | 4.7 | N/A | Ramp Cross Slope RT (%) | N/A |

Remove & Replace Entire Ramp.

R304.5.1, R304.5.3, STD 1115

Total Cost: \$ 2500
