# Access Compliance Report Public Rights-of-Way (Curb Ramps)

Main Street: BOLSA\_AVE Cross Street: PURDY\_ST Location: E

ADA ID: RPRK211005133002 Ramp Type: Type 4 - Parallel Initial Pass/Fail: Fail Overall Compliance: No Severity Score: 5

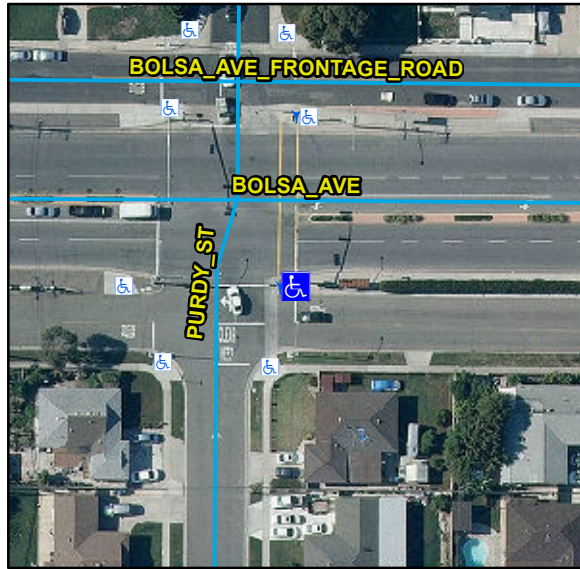
| Compliance | Description | Data | Compliance | Description | Data |
|---|---|---|---|---|---|
| No | Ramp Width LT (in) | 46 | N/A | Ramp Width RT (in) | N/A |
| No | Ramp Cross Slope LT (%) | 2.5 | N/A | Ramp Cross Slope RT (%) | N/A |

Remove & Replace Entire Ramp.

R304.5.1, R304.5.3, STD 1115
