Main Street: FAIRHAVEN\_AVE Cross Street: ESPLANADE\_AVE Location: NW

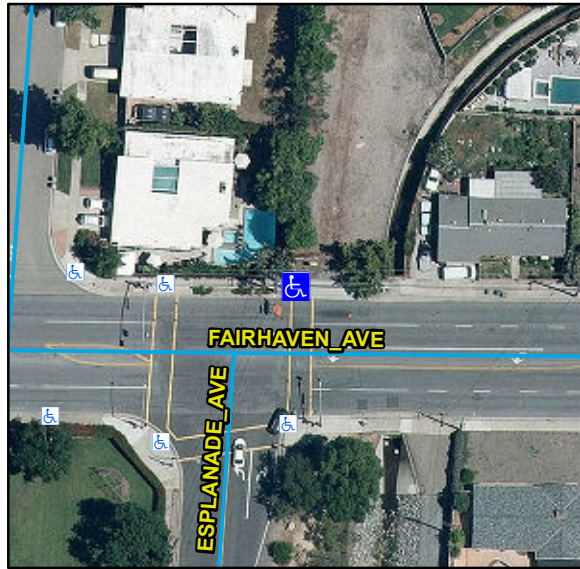
ADA ID: RPRK211007114948 Ramp Type: Type 1 - Perpendicular Initial Pass/Fail: Pass Overall Compliance: No Severity Score: 12

| Compliance | Description | Data | Compliance | Description | Data |
|---|---|---|---|---|---|
| No | Landing Width (in) | N/A | Yes | Flare Slope RT (%) | 6.3 |
| No | Landing Run Slope (%) | N/A | N/A | Flare Traversable RT | Yes |
| No | Landing Cross Slope (%) | N/A | Yes | DWS Provided | Yes |
| Yes | Gutter Ponding | No | No | Curb Slope | 18.1 |

### Possible Solutions:

Remove & Replace Entire Ramp.

Total Cost: \$ 3080
