# Access Compliance Report Public Rights-of-Way (Curb Ramps)

Main Street: ARROYO\_AVE Cross Street: SKYLINE\_DR Location: E

ADA ID: RPRK211011104956 Ramp Type: Type 1 - Perpendicular Diagonal Initial Pass/Fail: Pass Overall Compliance: No Severity Score: 15

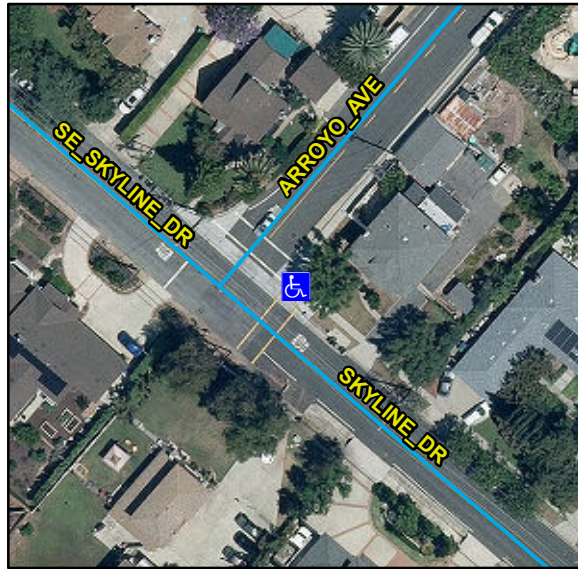
| Compliance | Description | Data | Compliance | Description | Data |
|---|---|---|---|---|---|
| No | Landing Width (in) | N/A | Yes | Flare Slope RT (%) | 5.2 |
| No | Landing Run Slope (%) | N/A | N/A | Flare Traversable RT | Yes |
| No | Landing Cross Slope (%) | N/A | Yes | DWS Provided | Yes |
| Yes | Gutter Ponding | No | No | Curb Slope | 17.4 |
| No | Gutter Run Slope (%) | 5.5 | | Road Cross Slope (%) | 1.8 |
| No | Gutter Cross Slope (%) | 3.8 | | | |

Remove & Replace Curb Ramp With Two New Directional Ramps or Equivalent. Remove & Replace Gutter.
