# Access Compliance Report Public Rights-of-Way (Curb Ramps)

Main Street: WARREN\_AVE Cross Street: CLARISSA\_LN Location: NE

ADA ID: RPRK211011145115 Ramp Type: Type 7 - Directional 2 Initial Pass/Fail: Pass Overall Compliance: No Severity Score: 4

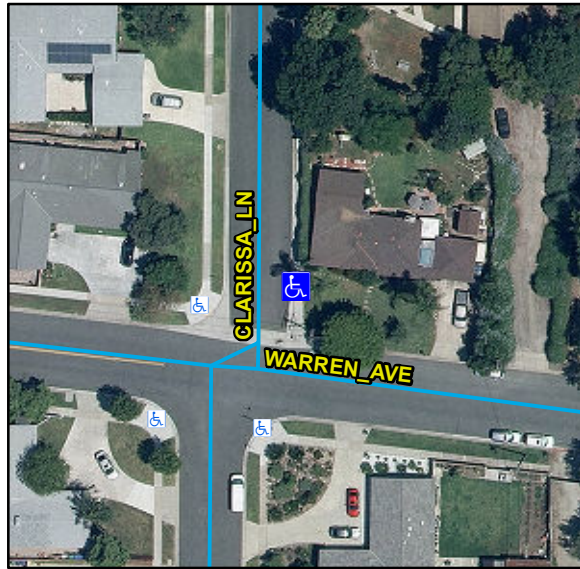
| Compliance | Description | Data | Compliance | Description | Data |
|---|---|---|---|---|---|
| No | Landing Length (in) | 46 | Yes | DWS Length (in) | 36 |
| N/A | Landing Movement Obstructed? | No | No | DWS Right Offset (in) | 120 |

Possible Solutions:

Remove & Replace Entire Ramp.

R204.3, R304.2.1, R305.2, STD 1115
