# Access Compliance Report Public Rights-of-Way (Curb Ramps)

Main Street: SKYWAY\_DR Cross Street: SKYLINE\_DR Location: E

ADA ID: RPRK211012115617 Ramp Type: Type 7 - Directional 2 Initial Pass/Fail: Fail Overall Compliance: No Severity Score: 16

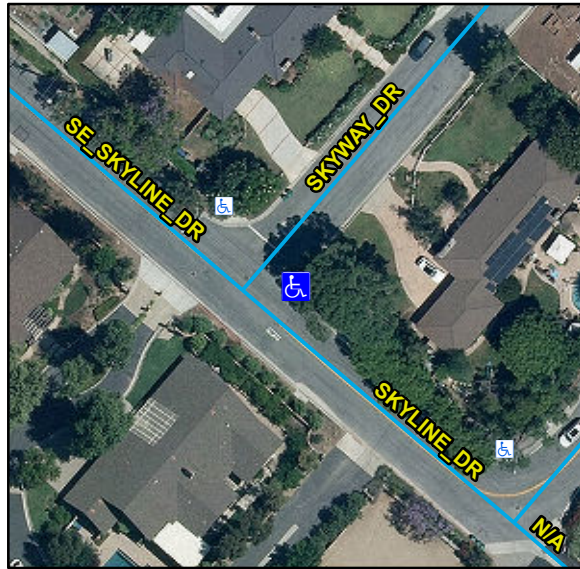
| Compliance | Description | Data | Compliance | Description | Data |
|---|---|---|---|---|---|
| No | Ramp Run Slope (%) | 8.6 | N/A | Flare Slope LT (%) | N/A |
| No | Ramp Cross Slope (%) | 2.4 | N/A | Flare Traversable LT | N/A |

Remove & Replace Entire Ramp.

R304.2.2, R304.5.3, STD 1115
