# Access Compliance Report Public Rights-of-Way (Curb Ramps)

| Main Street: CHADWICK_LN | | Cross Street: MARBLE_ARCH_DR | | Location: | E |
| ADA ID: RPRK211012131257 | Ramp Type: Type 6 - Directional 1 | Initial Pass/Fail: Pass | Overall Compliance: No | Severity Score: | 19 |

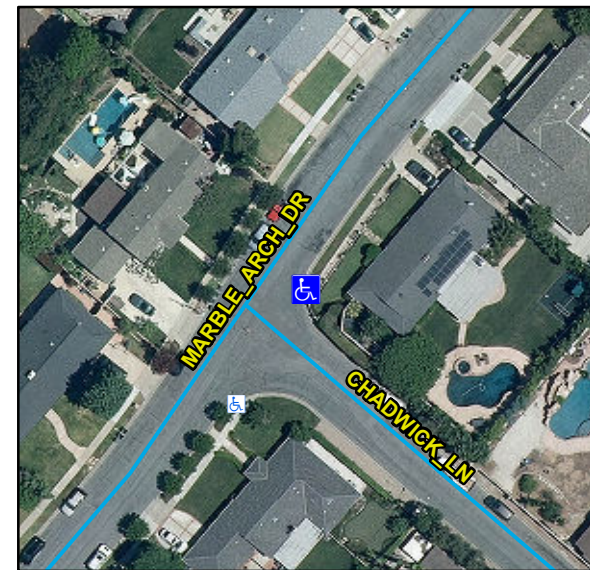
| Compliance | Description | Data | Compliance | Description | Data |
|---|---|---|---|---|---|
| No | Grade Break | No | Yes | Flare Type RT | |
| | Addl Para Ramp Right? | No | No | DWS Provided | No |
| No | Landing Width (in) | 46 | N/A | DWS Full Width | N/A |
| No | Gutter Run Slope (%) | 8.8 | | Road Cross Slope (%) | N/A |

Remove & Replace Entire Ramp. Remove & Replace Gutter.

R304.2.1, R304.5.2, R305, R304.5.4, STD 1115

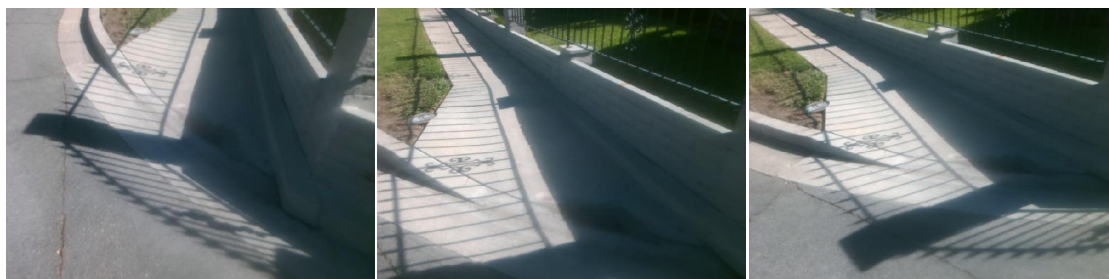
| Compliance | Description | Data | Compliance | Description | Data |
| N/A | Ramp Length (in) | 122 | N/A | Flare Type LT | |
| Yes | Ramp Width (in) | 60 | | | Sloped |
| Yes | Ramp Run Slope (%) | 8.1 | N/A | Flare Slope LT (%) | 15.1 |

#### Possible Solutions:
