# Access Compliance Report Public Rights-of-Way (Curb Ramps)

Main Street: SHEPPARD\_WAY Cross Street: GATEWAY\_DR Location: W

ADA ID: RPRK211013170906 Ramp Type: Type 4 - Parallel Initial Pass/Fail: Fail Overall Compliance: No Severity Score: 2

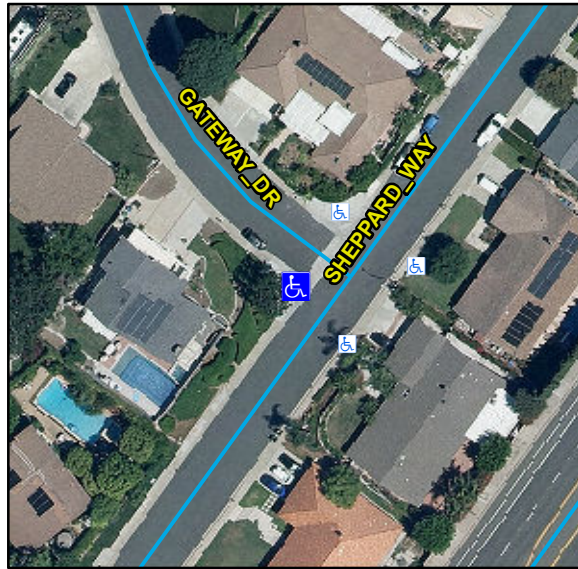
| Compliance | Description | Data | Compliance | Description | Data |
|---|---|---|---|---|---|
| No | Ramp Cross Slope LT (%) | 2.4 | No | Ramp Cross Slope RT (%) | 4.4 |

**Remove & Replace Curb Ramp With Two New Directional Ramps or Equivalent.**

**R304.5.3, STD 1115**

Total Cost: \$ 4000
