# Access Compliance Report Public Rights-of-Way (Curb Ramps)

Main Street: **BROWNING\_AVE** Cross Street: **LA\_COLINA\_DR** Location: **SE**

ADA ID: **RPRK211014133803** Ramp Type: **Type 4 - Parallel** Initial Pass/Fail: **Fail** Overall Compliance: **No** Severity Score: **15**

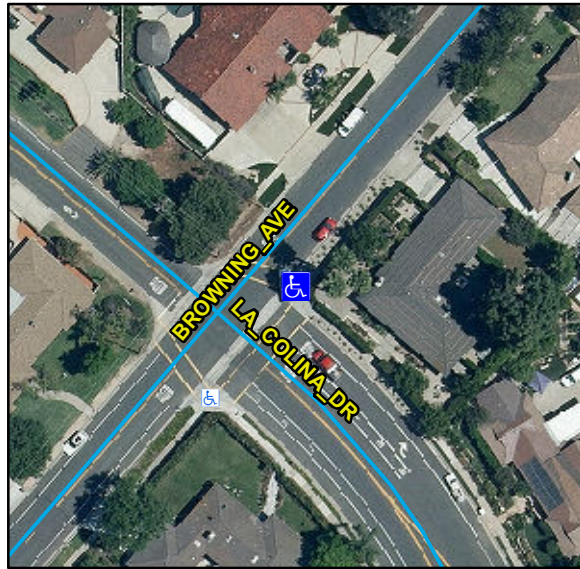
| Compliance | Description | Data | Compliance | Description | Data |
|---|---|---|---|---|---|
| <b>No</b> | Ramp Run Slope LT (%) | <b>8.4</b> | <b>Yes</b> | Ramp Run Slope RT (%) | <b>8.3</b> |

**Remove & Replace Curb Ramp With Two New Directional Ramps or Equivalent.**

**R304.3.2, STD 1115**
