# Access Compliance Report Public Rights-of-Way (Curb Ramps)

Main Street: WILLO\_LN Cross Street: UNIVERSITY\_DR Location: S

ADA ID: RPRK211018112219 Ramp Type: Type 6 - Directional 1 Initial Pass/Fail: Pass Overall Compliance: No Severity Score: 10

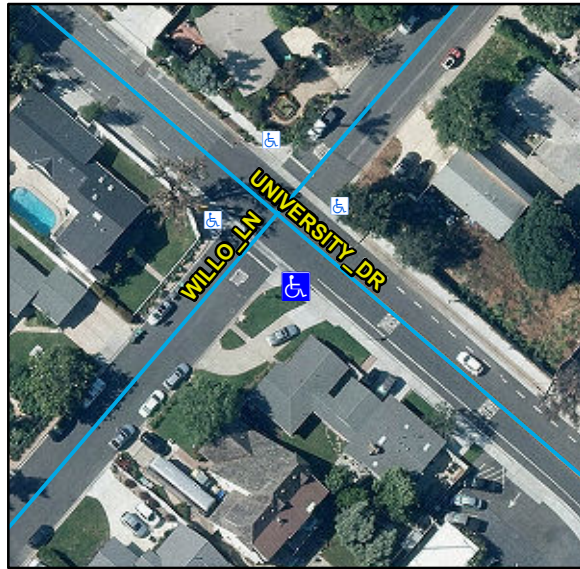
| Compliance | Description | Data | Compliance | Description | Data |
|---|---|---|---|---|---|
| No | Grade Break Slope (%) | 8.3 | | | Curbed2 |
| No | Landing Length (in) | N/A | Yes | DWS Length (in) | 84 |
| No | Landing Width (in) | N/A | Yes | DWS Full Width | Yes |
| No | Landing Run Slope (%) | N/A | | DWS Offset Type | Single |
| No | Landing Cross Slope (%) | N/A | Yes | DWS Left Offset (in) | 0 |

Remove & Replace Entire Ramp.

R304.2.1, R304.2.2-Perp, R304.3.2-Para, R304.5.3, STD 1115

Total Cost: \$ 3080
