# Access Compliance Report Public Rights-of-Way (Curb Ramps)

Main Street: IRVINE\_AVE Cross Street: LA\_CANADA\_WAY Location: W

ADA ID: RPRK211018120304 Ramp Type: Type 4 - Parallel Initial Pass/Fail: Pass Overall Compliance: No Severity Score: 0

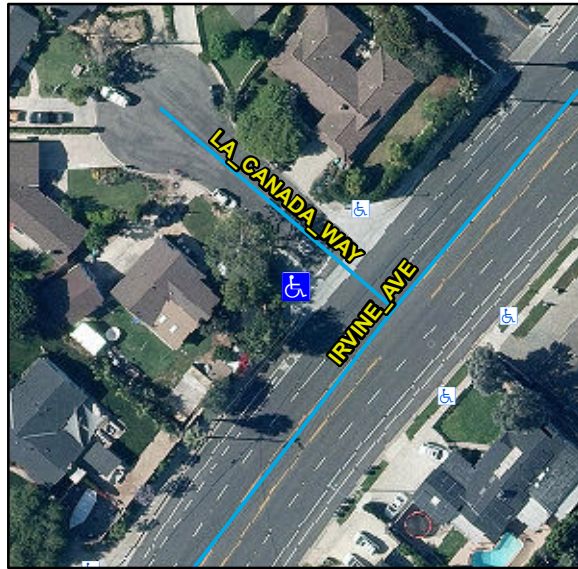
| Compliance | Description | Data | Compliance | Description | Data |
|---|---|---|---|---|---|
| Yes | Gutter Ponding | No | No | Curb Slope | 10.8 |

Remove & Replace Curb Slope.

R304.2.2, STD 1115
