# Access Compliance Report Public Rights-of-Way (Curb Ramps)

Main Street: ANNIVERSARY\_LN Cross Street: IRVINE\_AVE Location: SE

ADA ID: RPRK211018122450 Ramp Type: Type 7 - Directional 2 Initial Pass/Fail: Pass Overall Compliance: No Severity Score: 4

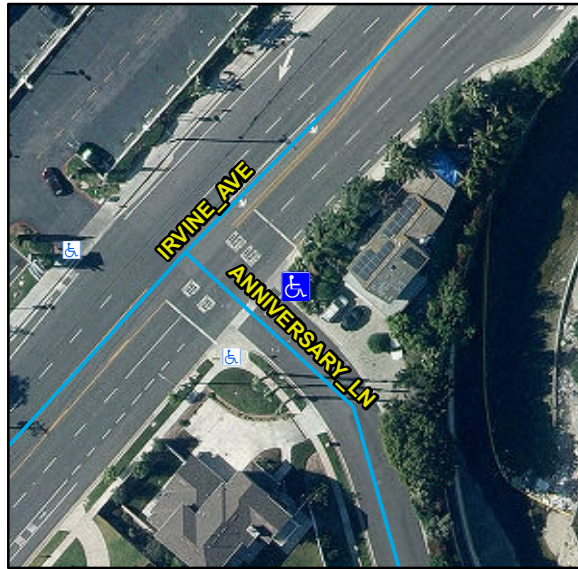
| Compliance | Description | Data | Compliance | Description | Data |
|---|---|---|---|---|---|
| No | Landing Length (in) | 39 | Yes | DWS Length (in) | 36 |
| No | Landing Cross Slope (%) | 2.1 | Yes | DWS Left Offset (in) | 0 |
| Yes | Gutter Ponding | No | No | Curb Slope | 54 |
| No | Gutter Cross Slope (%) | 5.3 | | Parallel Ramp Side | Right |

Remove & Replace Entire Ramp. Remove & Replace Gutter.

R304.2.2, R204.3, R304.2.1, R304.5.3, R305.2, STD 1115
