# Access Compliance Report Public Rights-of-Way (Curb Ramps)

Main Street: CRESTVIEW Cross Street: CASTLETREE Location: S

ADA ID: RPRK211018152036 Ramp Type: Type 1 - Perpendicular Diagonal Initial Pass/Fail: Pass Overall Compliance: No Severity Score: 62

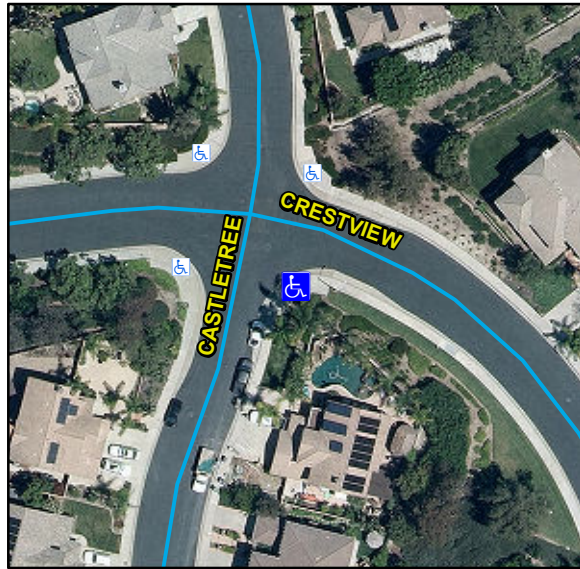
| Compliance | Description | Data | Compliance | Description | Data |
|---|---|---|---|---|---|
| Yes | Ramp Run Slope (%) | 7.7 | No | Flare Slope LT (%) | 20.1 |
| No | Ramp Cross Slope (%) | 9 | N/A | Flare Traversable LT | Yes |
| No | Landing Cross Slope (%) | 10.7 | No | DWS Provided | No |
| No | Gutter Lip Height (in) | 0.5 | | Road Run Slope (%) | 7.9 |
| No | Gutter Run Slope (%) | 8.7 | | Road Cross Slope (%) | 4.6 |
| No | Gutter Cross Slope (%) | 7.7 | | | |

Remove & Replace Curb Ramp With Two New Directional Ramps or Equivalent. Remove & Replace Gutter.

R304.5.3, R304.2.1, R304.2.3, R305, R302.7.2, R304.5.4, STD 1115
