# Access Compliance Report Public Rights-of-Way (Curb Ramps)

Main Street: SUMMIT\_CT Cross Street: STARLIGHT\_RIDGE Location: SW

ADA ID: RPRK211018173546 Ramp Type: Type 4 - Parallel Initial Pass/Fail: Fail Overall Compliance: No Severity Score: 30

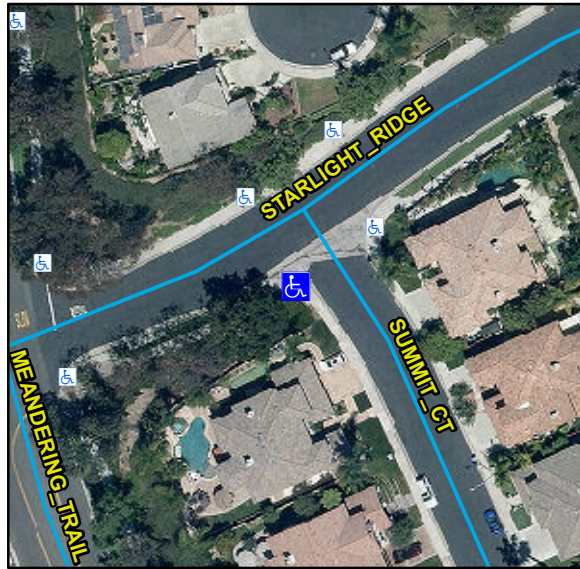
| Compliance | Description | Data | Compliance | Description | Data |
|---|---|---|---|---|---|
| No | Ramp Run Slope LT (%) | 18.5 | Yes | Ramp Run Slope RT (%) | 3 |

Remove & Replace Curb Ramp With Two New Directional Ramps or Equivalent.
