# Access Compliance Report Public Rights-of-Way (Curb Ramps)

Main Street: CHANDLER\_PL Cross Street: EDMONTON\_WAY Location: SW

ADA ID: RPRK211019145202 Ramp Type: Type 4 - Parallel Initial Pass/Fail: Fail Overall Compliance: No Severity Score: 30

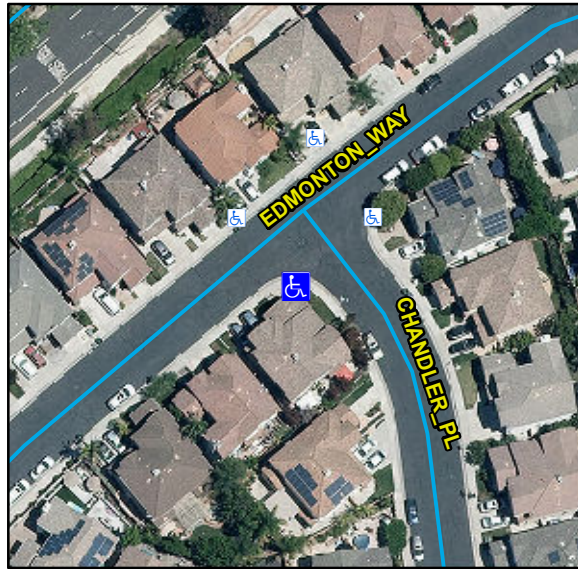
| Compliance | Description | Data | Compliance | Description | Data |
|---|---|---|---|---|---|
| No | Ramp Cross Slope LT (%) | 12.2 | No | Ramp Cross Slope RT (%) | 12.7 |
| N/A | Gutter Ponding | N/A | No | Curb Slope | 16.9 |

**Remove & Replace Curb Ramp With Two New Directional Ramps or Equivalent.**

**R304.2.2, R204.3, R304.5.3, STD 1115**
