# Access Compliance Report Public Rights-of-Way (Curb Ramps)

Main Street: CLAYMONT\_DR Cross Street: ALLBROOK\_CT Location: W

ADA ID: RPRK211020174955 Ramp Type: Type 4 - Parallel Initial Pass/Fail: Fail Overall Compliance: No Severity Score: 15

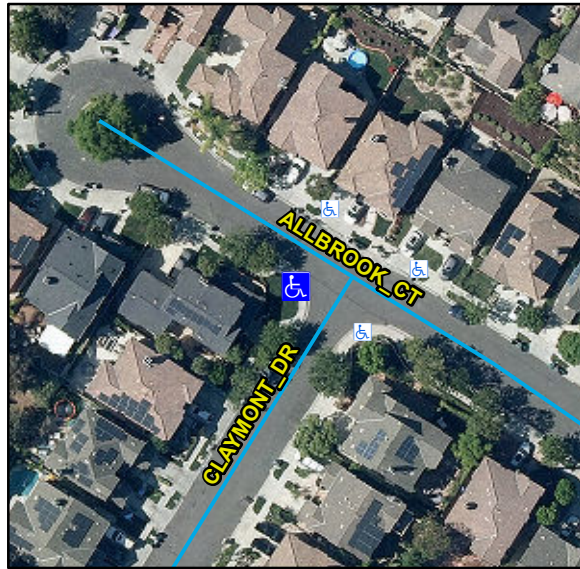
| Compliance | Description | Data | Compliance | Description | Data |
|---|---|---|---|---|---|
| Yes | Ramp Run Slope LT (%) | 3.7 | No | Ramp Run Slope RT (%) | 9.3 |

Remove & Replace Curb Ramp With Two New Directional Ramps or Equivalent.

R204.3, R304.3.2, STD 1115

Total Cost: \$ 4000
