# Access Compliance Report Public Rights-of-Way (Curb Ramps)

Main Street: **OSO\_PKWY** Cross Street: **LOS\_PATRONES\_PKWY** Location: **NW**

ADA ID: **RPRK211021115302** Ramp Type: **Type 1 - Perpendicular Diagonal** Initial Pass/Fail: **Pass** Overall Compliance: **No** Severity Score: **0**

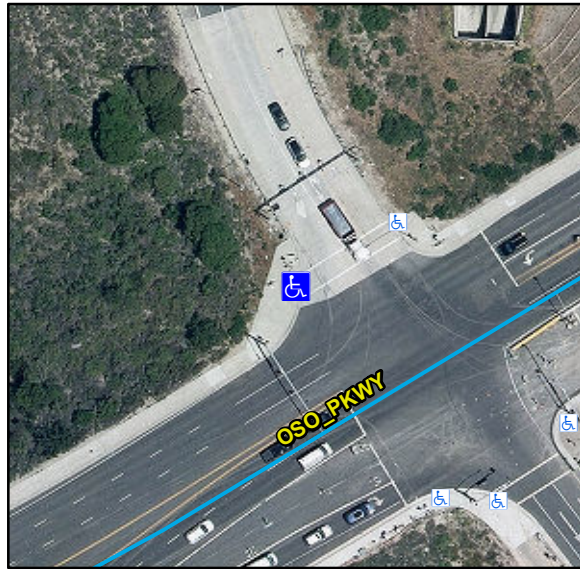
| Compliance | Description | Data | Compliance | Description | Data |
|---|---|---|---|---|---|
| <b>Yes</b> | Gutter Ponding | <b>No</b> | <b>No</b> | Curb Slope | <b>14.6</b> |

**Remove & Replace Curb Slope.**

**R304.2.2, STD 1115**
