# Access Compliance Report Public Rights-of-Way (Curb Ramps)

Main Street: BLAKEMORE\_DR Cross Street: SIENNA\_PKWY Location: SE

ADA ID: RPRK211021143028 Ramp Type: Type 1 - Perpendicular Diagonal Initial Pass/Fail: Pass Overall Compliance: No Severity Score: 4

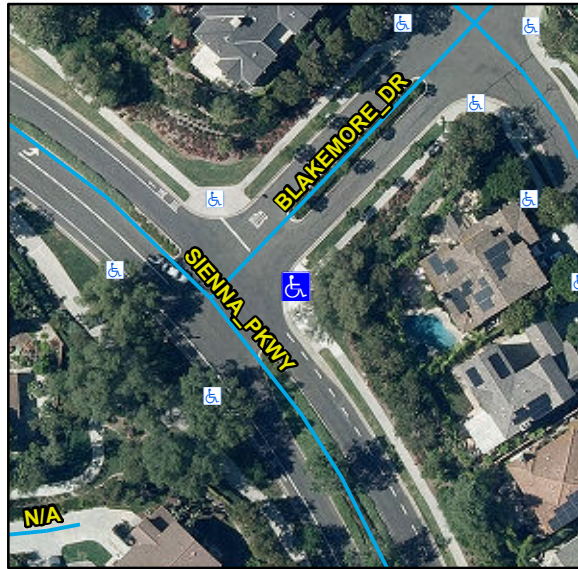
| Compliance | Description | Data | Compliance | Description | Data |
|---|---|---|---|---|---|
| N/A | Landing Length (in) | 40 | | | Sloped |

Remove & Replace Landing.

R304.2.1, STD 1115

Total Cost: \$ 531
