# Access Compliance Report

## Public Rights-of-Way

### (Curb Ramps)

Main Street: CROWN\_VALLEY\_PKWY Cross Street: O\_NEILL\_DR Location: SE

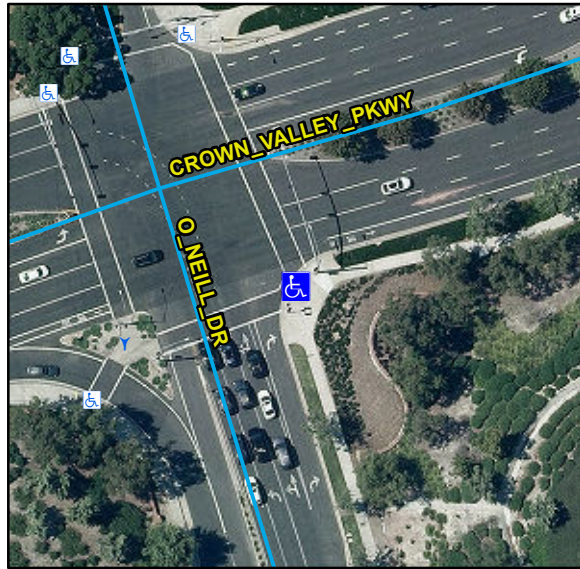
ADA ID: RPRK211025135904 Ramp Type: Type 1 - Perpendicular Diagonal Initial Pass/Fail: Pass Overall Compliance: No Severity Score: 2

| Compliance | Description | Data | Compliance | Description | Data |
|---|---|---|---|---|---|
| No | Ramp Cross Slope (%) | 4.4 | N/A | Flare Traversable LT | Yes |
| No | Landing Run Slope (%) | 3.4 | N/A | Flare Traversable RT | Yes |
| No | Landing Cross Slope (%) | 4.6 | Yes | DWS Provided | Yes |
| No | Gutter Cross Slope (%) | 2.5 | | | |

Remove & Replace Curb Ramp With Two New Directional Ramps or Equivalent. Remove & Replace Gutter.

R304.5.3, R304.2.2-Perp, R304.3.2-Para, STD 1115
