# Access Compliance Report Public Rights-of-Way (Curb Ramps)

Main Street: CECIL\_PASTURE\_RD Cross Street: CECIL\_PASTURE\_RD Location: SW

ADA ID: RPRK211026124007 Ramp Type: Type 6 - Directional 1 Initial Pass/Fail: Pass Overall Compliance: No Severity Score: 5

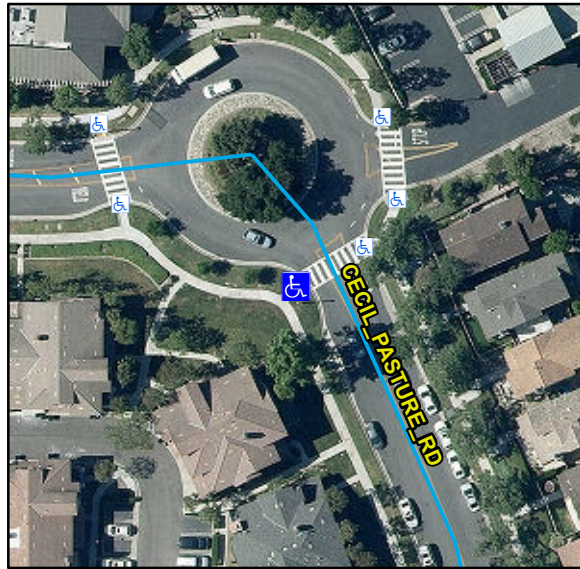
| Compliance | Description | Data | Compliance | Description | Data |
|---|---|---|---|---|---|
| No | Grade Break | No | Yes | Flare Type RT | |
| No | Gutter Run Slope (%) | 11.1 | | Road Cross Slope (%) | N/A |

**Remove & Replace Entire Ramp. Remove & Replace Gutter.**

**R304.5.2, R304.5.4, STD 1115**
