# Access Compliance Report Public Rights-of-Way (Curb Ramps)

Main Street: O\_NEILL\_DR Cross Street: N/A Location: NE

ADA ID: RPRK211026131751 Ramp Type: Type 4 - Parallel Initial Pass/Fail: Fail Overall Compliance: No Severity Score: 16

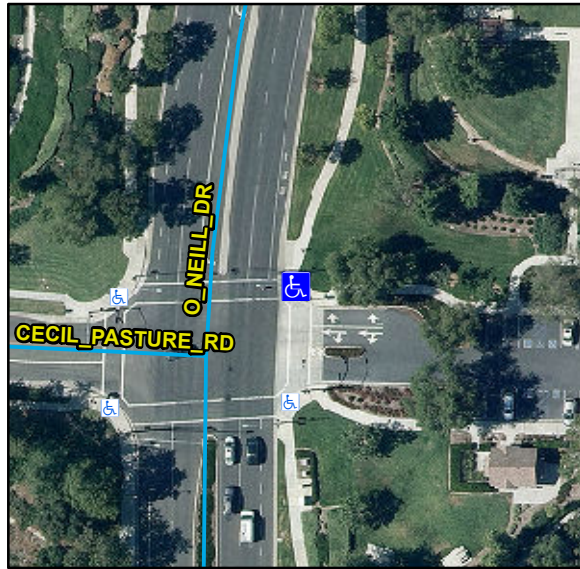
| Compliance | Description | Data | Compliance | Description | Data |
|---|---|---|---|---|---|
| Yes | Ramp Run Slope LT (%) | 7.1 | No | Ramp Run Slope RT (%) | 8.9 |
| Yes | Ramp Cross Slope LT (%) | 0.8 | No | Ramp Cross Slope RT (%) | 2.9 |

**Remove & Replace Curb Ramp With Two New Directional Ramps or Equivalent.**

**R204.3, R304.3.2, R304.5.3, STD 1115**
