# Access Compliance Report Public Rights-of-Way (Curb Ramps)

Main Street: N/A Cross Street: O\_NEILL\_DR Location: SE

ADA ID: RPRK211026132233 Ramp Type: Type 4 - Parallel Initial Pass/Fail: Pass Overall Compliance: No Severity Score: 20

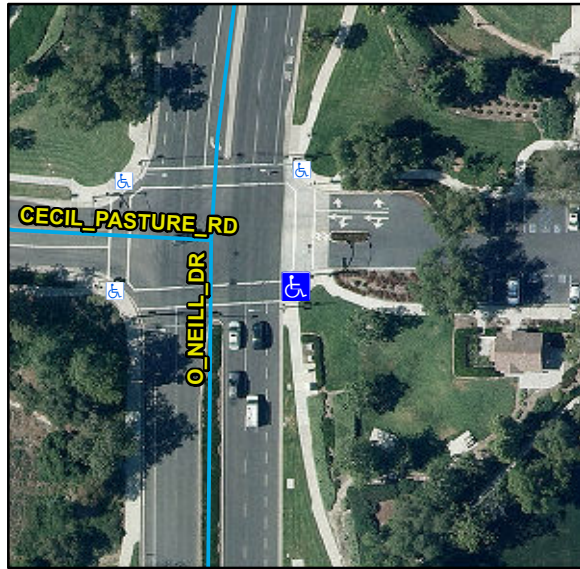
| Compliance | Description | Data | Compliance | Description | Data |
|---|---|---|---|---|---|
| N/A | Landing Present | No | No | DWS Provided | No |
| No | Landing Width (in) | N/A | N/A | DWS Length (in) | N/A |
| No | Landing Run Slope (%) | N/A | N/A | DWS Full Width | N/A |
| No | Landing Cross Slope (%) | N/A | | DWS Offset Type | N/A |
| Yes | Gutter Cross Slope (%) | 0.9 | No | Perpendicular Joint Present | No |

**Remove & Replace Curb Ramp With Two New Directional Ramps or Equivalent.**

**R204.3, R304.2.1, R304.2.2-Perp, R304.3.2-Para, R304.5.3, R305, STD 1115**

Total Cost: \$ 4000
