# Access Compliance Report Public Rights-of-Way (Curb Ramps)

Main Street: **NARROW\_CANYON\_RD** Cross Street: **AURA\_LN** Location: **SW**

ADA ID: **RPRK211028123801** Ramp Type: **Type 4 - Parallel** Initial Pass/Fail: **Fail** Overall Compliance: **No** Severity Score: **16**

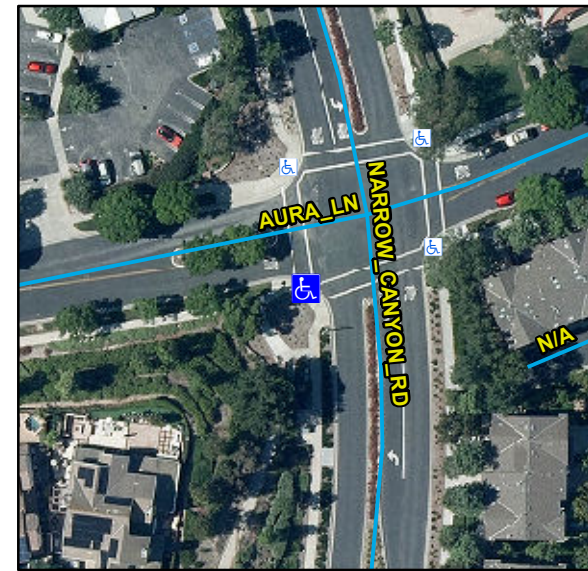
| Compliance | Description | Data | Compliance | Description | Data |
|---|---|---|---|---|---|
| <b>Yes</b> | Ramp Run Slope LT (%) | <b>1</b> | <b>No</b> | Ramp Run Slope RT (%) | <b>8.5</b> |
| <b>No</b> | Ramp Cross Slope LT (%) | <b>2.3</b> | <b>No</b> | Ramp Cross Slope RT (%) | <b>2.8</b> |

**Remove & Replace Curb Ramp With Two New Directional Ramps or Equivalent.**
