# Access Compliance Report Public Rights-of-Way (Curb Ramps)

Main Street: AURA\_LN Cross Street: NARROW\_CANYON\_RD Location: NW

ADA ID: RPRK211028125607 Ramp Type: Type 4 - Parallel Initial Pass/Fail: Pass Overall Compliance: No Severity Score: 25

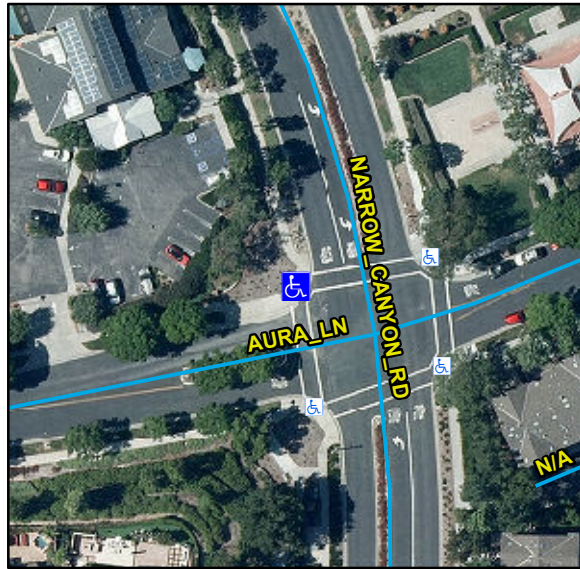
| Compliance | Description | Data | Compliance | Description | Data |
|---|---|---|---|---|---|
| Yes | Ramp Run Slope LT (%) | 3.1 | Yes | Ramp Run Slope RT (%) | 6.7 |
| N/A | Landing Present | No | No | DWS Provided | No |
| No | Landing Width (in) | N/A | N/A | DWS Length (in) | N/A |
| No | Landing Run Slope (%) | N/A | N/A | DWS Full Width | N/A |
| No | Landing Cross Slope (%) | N/A | | DWS Offset Type | N/A |
| Yes | Gutter Ponding | No | No | Curb Slope | 8.9 |
| No | Gutter Run Slope (%) | 6.8 | | Road Cross Slope (%) | 2 |

Remove & Replace Curb Ramp With Two New Directional Ramps or Equivalent. Remove & Replace Gutter.

R304.2.2, R304.2.1, R304.2.2-Perp, R304.3.2-Para, R304.5.3, R305, R304.5.4, STD 1115
