# Access Compliance Report Public Rights-of-Way (Curb Ramps)

Main Street: **NARROW\_CANYON\_RD** Cross Street: **AURA\_LN** Location: **NE**

ADA ID: **RPRK211028125912** Ramp Type: **Type 4 - Parallel** Initial Pass/Fail: **Fail** Overall Compliance: **No** Severity Score: **2**

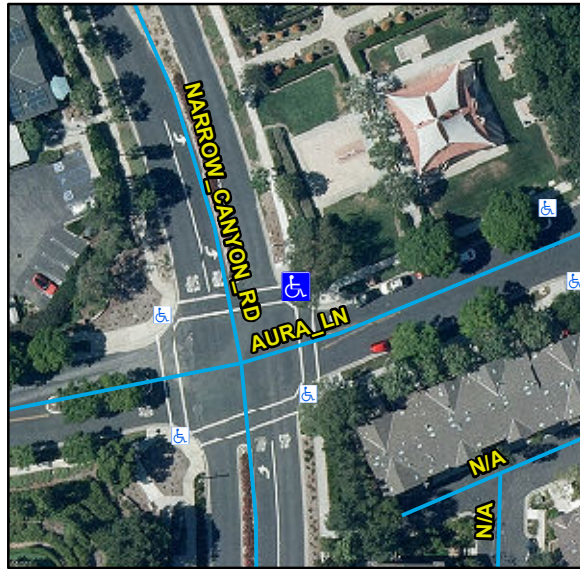
| Compliance | Description | Data | Compliance | Description | Data |
|---|---|---|---|---|---|
| <b>No</b> | Ramp Cross Slope LT (%) | <b>2.1</b> | <b>No</b> | Ramp Cross Slope RT (%) | <b>4.4</b> |

**Remove & Replace Curb Ramp With Two New Directional Ramps or Equivalent.**

**R204.3, R304.5.3, STD 1115**
