# Access Compliance Report Public Rights-of-Way (Curb Ramps)

| Main Street: RESTON_WAY | | Cross Street: RESTON_WAY | | Location: | E |
| ADA ID: RPRK211101130601 | Ramp Type: Type 4 - Parallel | Initial Pass/Fail: Pass | Overall Compliance: No | Severity Score: | 25 |

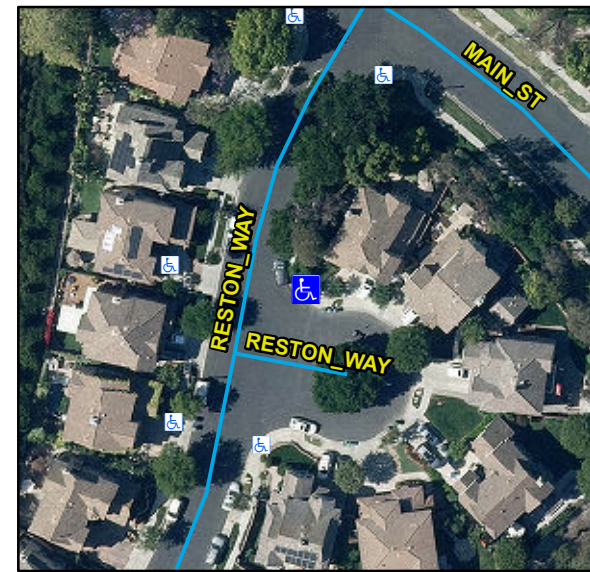
| Compliance | Description | Data | Compliance | Description | Data |
|---|---|---|---|---|---|
| N/A | Landing Present | No | No | DWS Provided | No |
| No | Landing Width (in) | N/A | N/A | DWS Length (in) | N/A |
| No | Landing Run Slope (%) | N/A | N/A | DWS Full Width | N/A |
| No | Landing Cross Slope (%) | N/A | | DWS Offset Type | N/A |
| No | Gutter Ponding | Yes | No | Curb Slope | 13.6 |
| No | Gutter Run Slope (%) | 11.2 | | Road Cross Slope (%) | 4.6 |

Remove & Replace Curb Ramp With Two New Directional Ramps or Equivalent. Remove & Replace Gutter.
